**KOMITE NASIONAL KESELAMATAN TRANSPORTASI  
REPUBLIC OF INDONESIA**

## **KNKT.21.01.01.04**

### **Aircraft Accident Investigation Report**

**PT Sriwijaya Air**  
**Boeing 737-500; PK-CLC**  
**Kepulauan Seribu District, DKI Jakarta**  
**Republic of Indonesia**  
**9 January 2021**

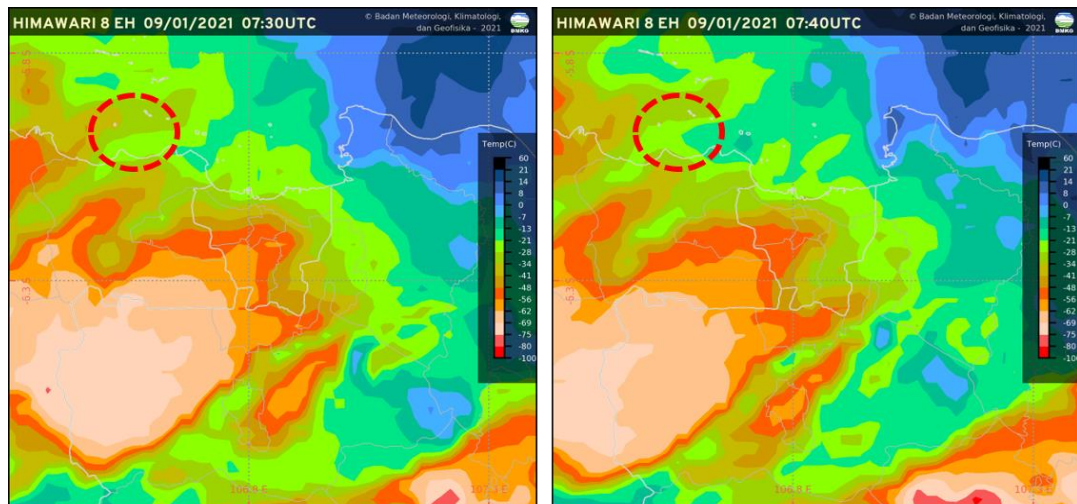
**Figure 7: Enhanced infrared satellite image at 0730 UTC and 0740 UTC at accident site (red-dotted circle)**

The *Badan Meteorologi Klimatologi dan Geofisika* (BMKG – Bureau of Meteorology, Climatology and Geophysics) provided enhanced infrared satellite images. The enhanced infrared satellite images at 0730 UTC (1430 LT) and 0740 UTC (1440 LT) indicated that the cloud top temperature at the accident site (red circle) was from -34°C to -21°C.

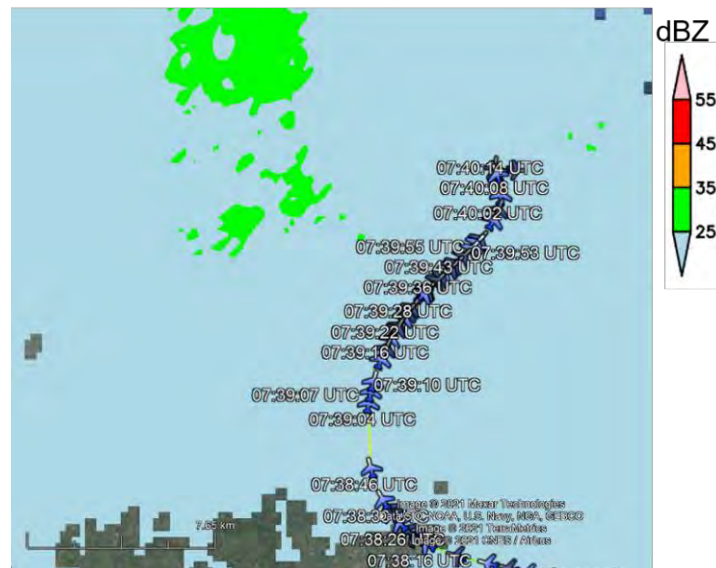
**Figure 8: The superimposed accident flight profile based on ADS-B- with BMKG radar weather image at 1438 LT**

The superimposed ADS-B-based flight profile with radar weather image at 1438 LT provided by the BMKG indicated that the radar intensity level along the flight profile was not more than 25 dBZ<sup>13</sup>, which means that the flight path did not indicate any significant development of clouds.

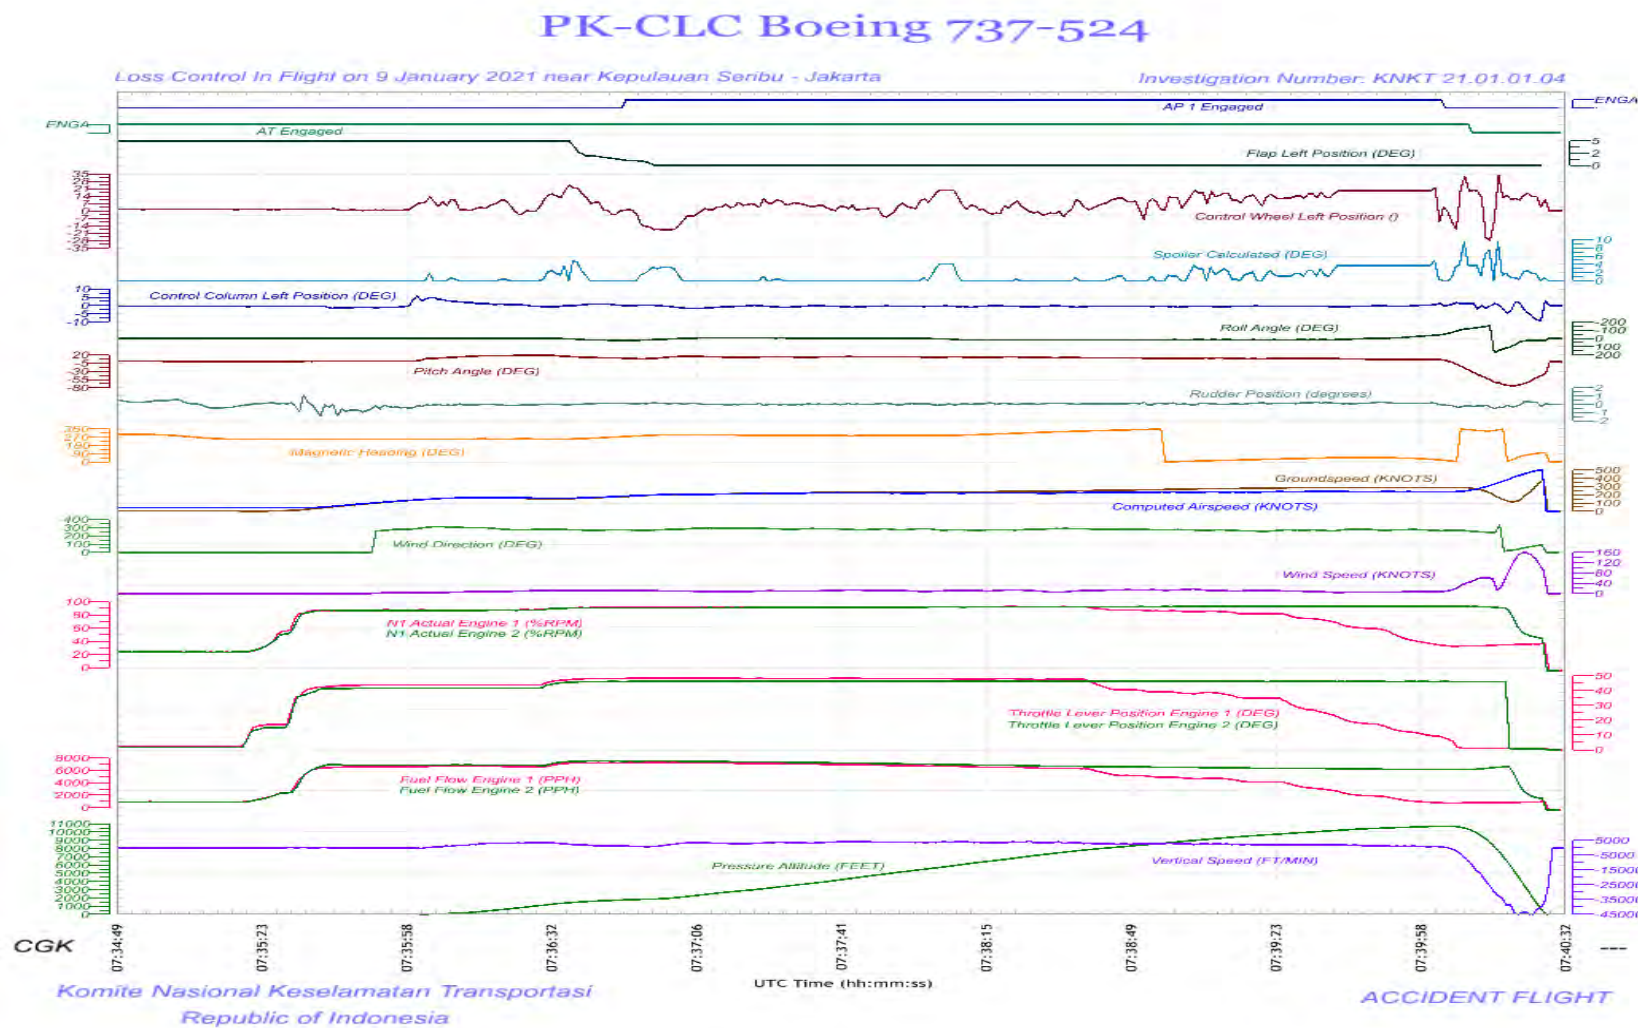
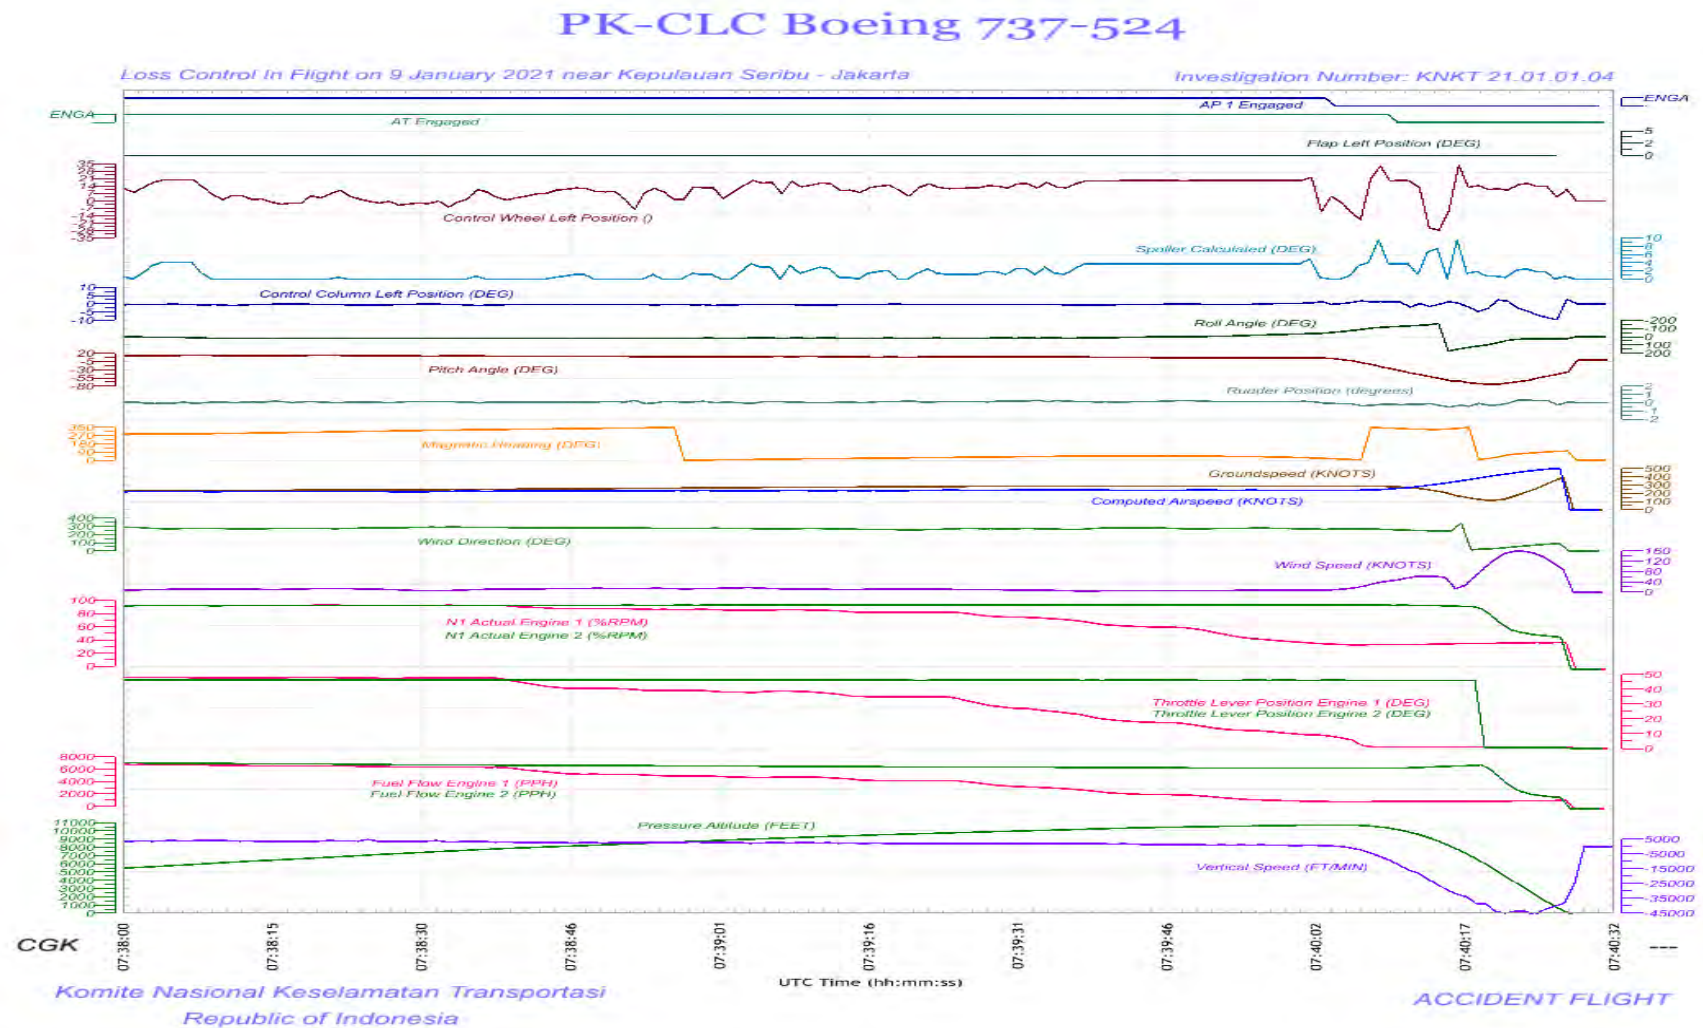
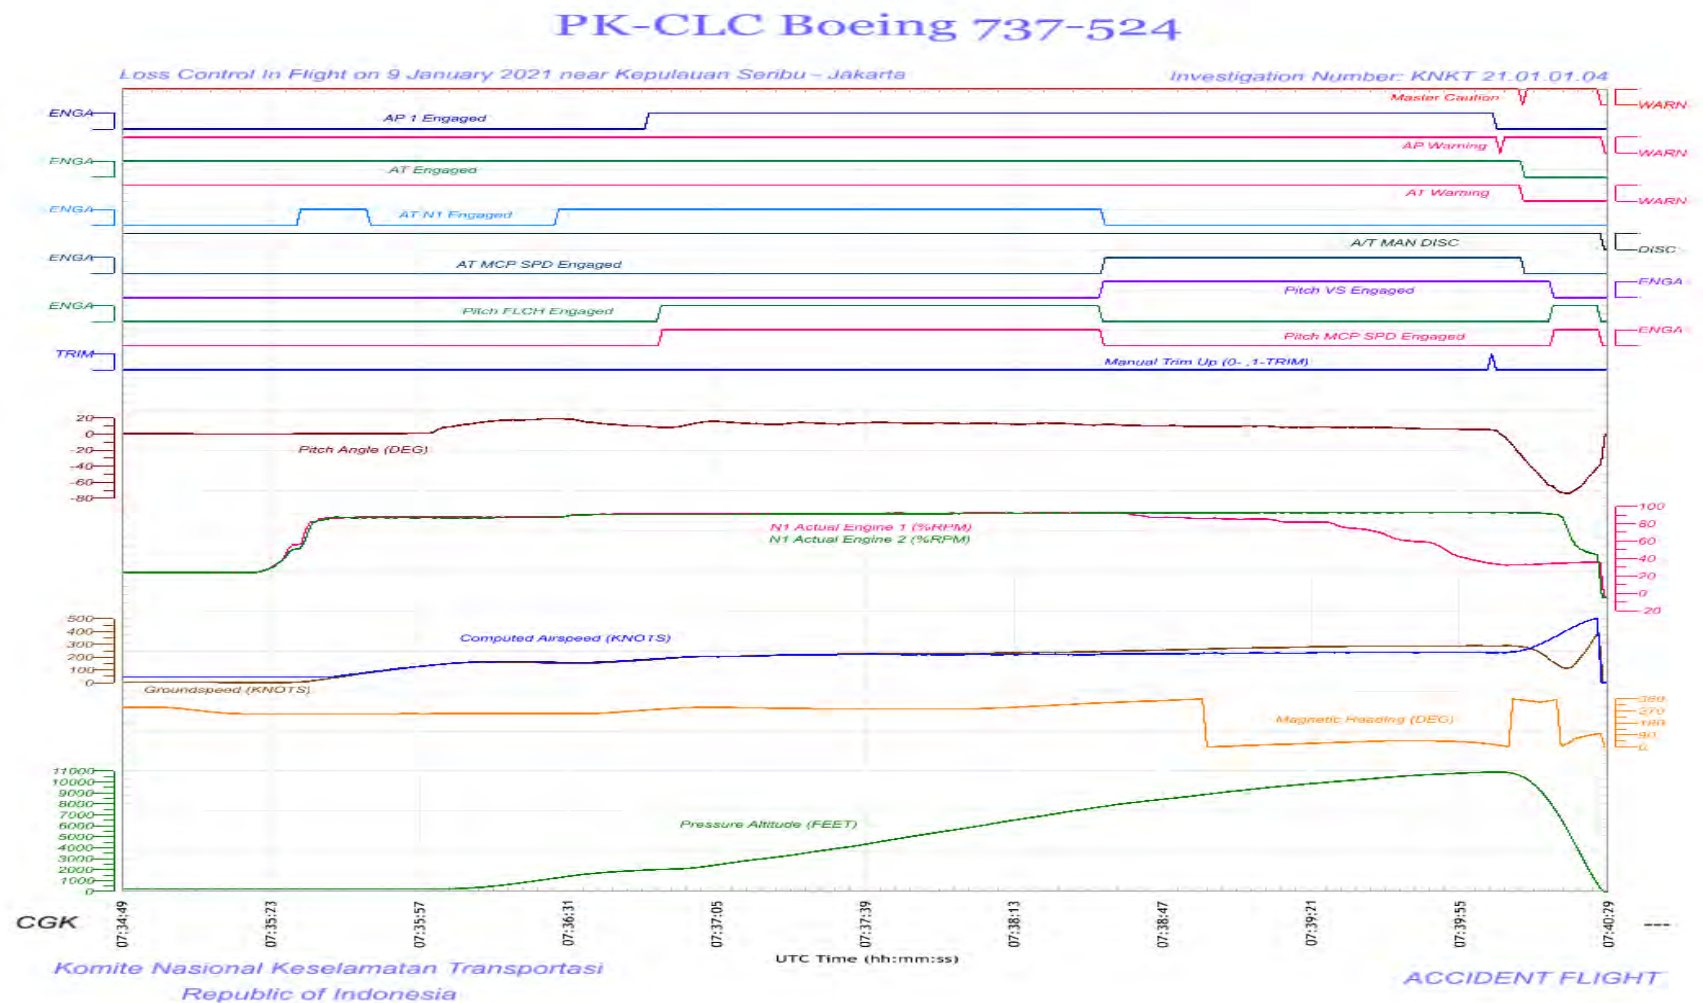
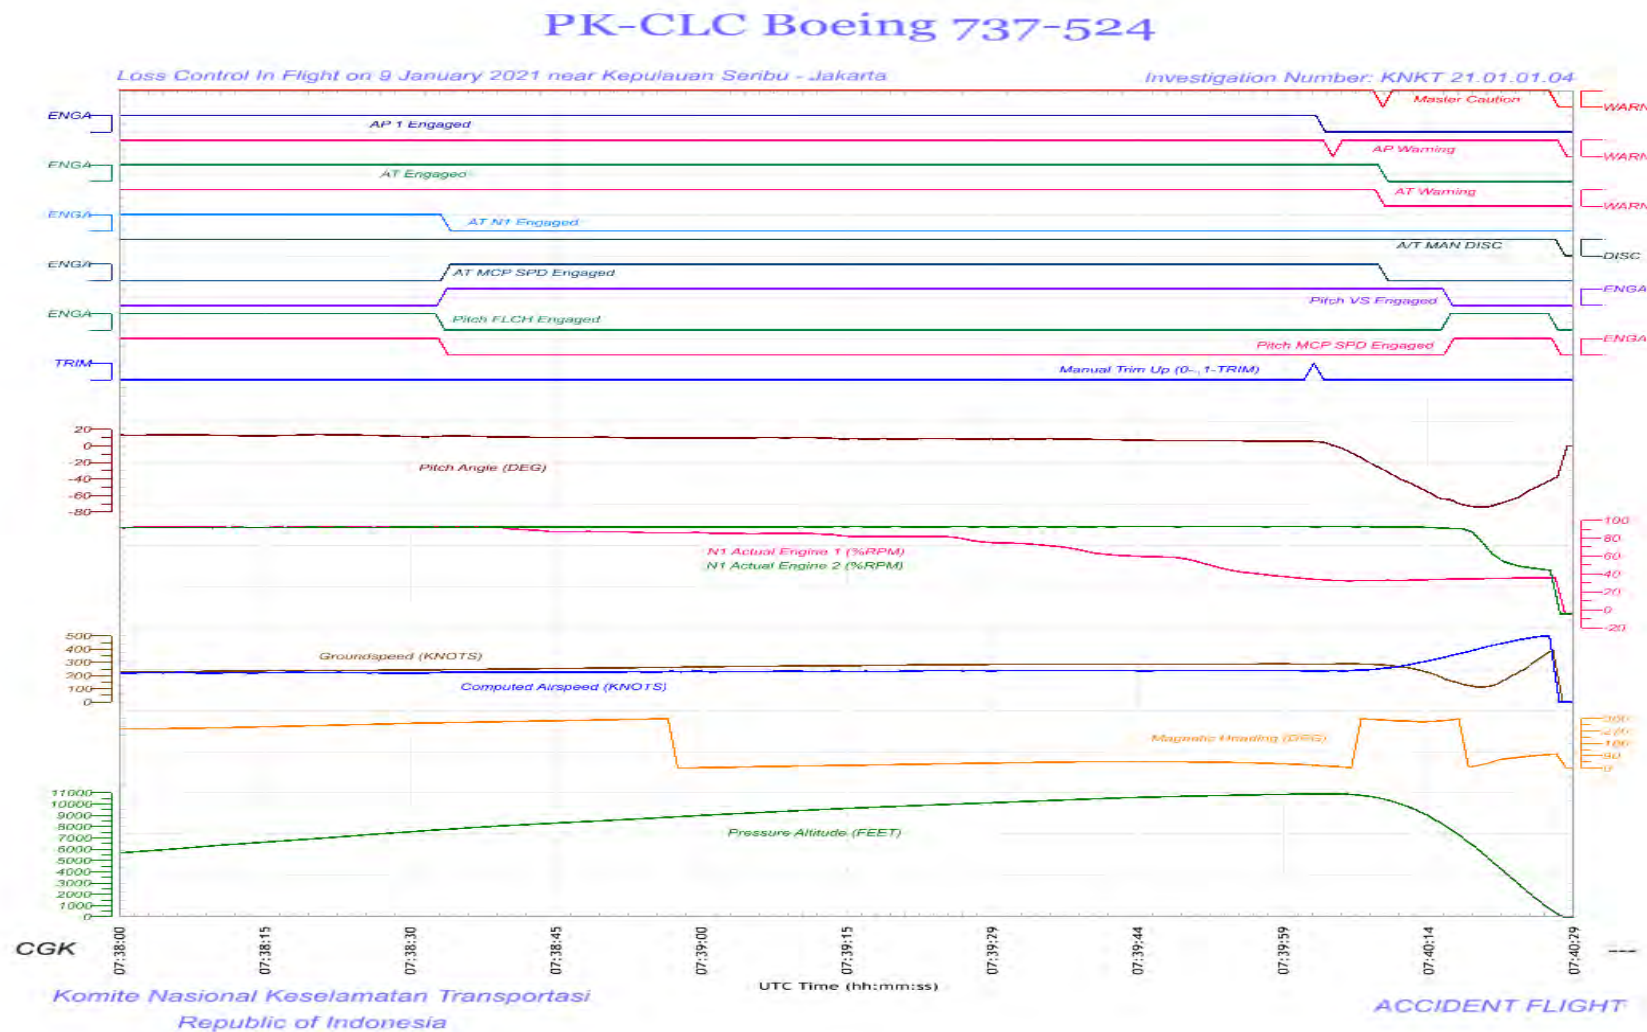
Figure 10: The significant FDR parameters of flight instrument of the accident flight

The FDR did not record the aircraft rate of climb/descend and the spoiler deflection angle. The data for these parameters in this investigation report were based on calculation. Boeing estimated the flight spoiler positions by correlating the spoilers to the control wheel positions recorded on the FDR. The calculation assumed nominal aircraft rigging and a neutral aileron trim setting, which could not be verified for the accident flight.

The FDR data showed that:

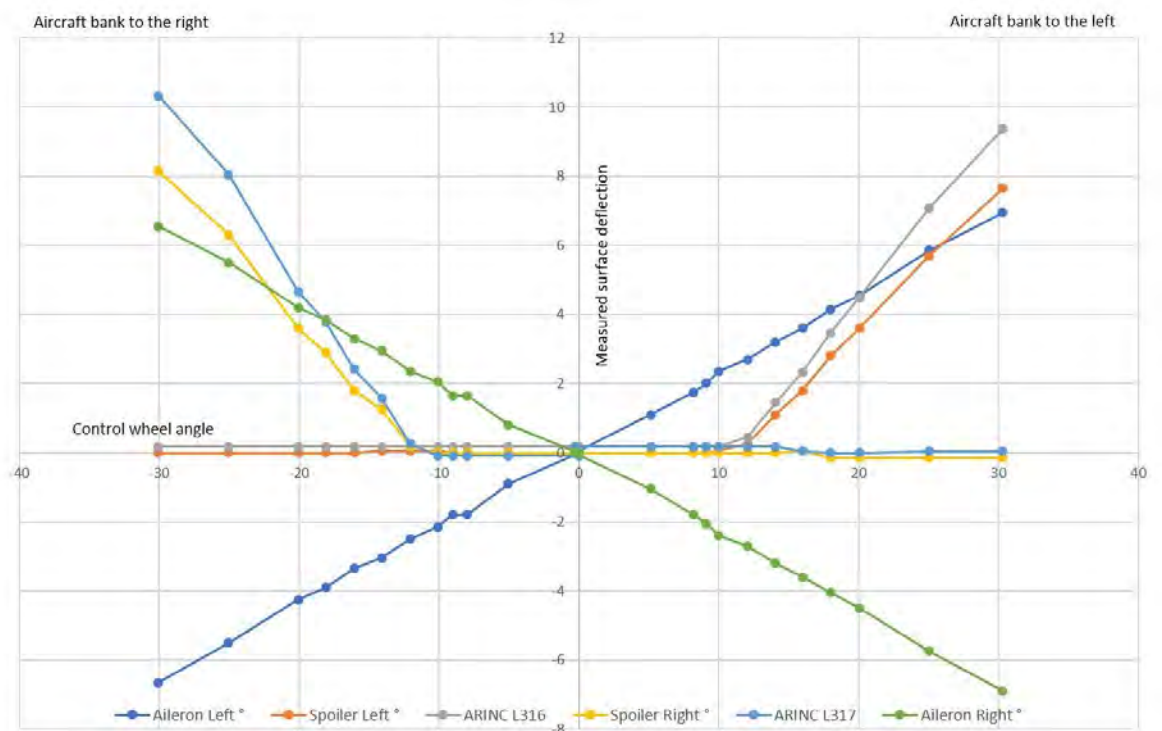
**Figure 22: Aileron and spoiler deflection test result (surface deflect up = positive value)**

The test verified that the spoiler position angle matched to the spoiler position output from the FCC. The relationship chart of the aileron and flight spoiler deflection is shown in the figure below.

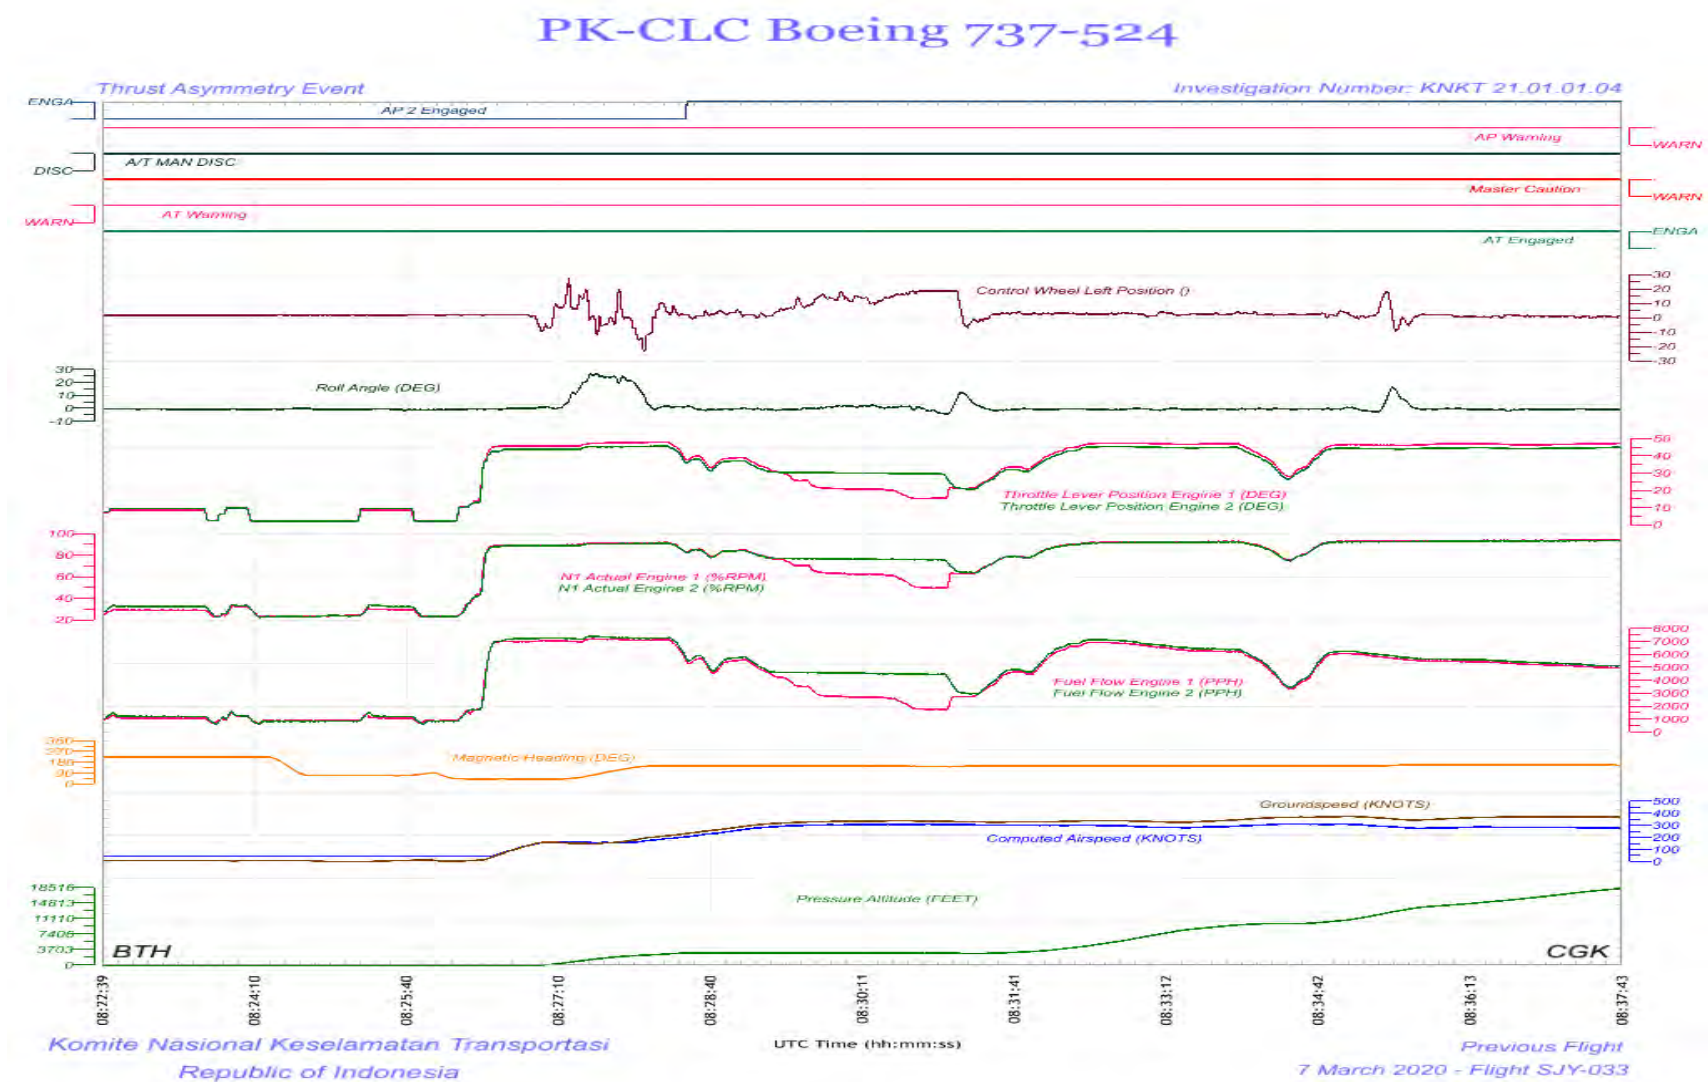
Figure 31: The QAR data of a flight on 7 March 2020

The QAR data of a flight on 7 March 2020 showed that:

The investigation team has interviewed both pilots of this flight. None of the pilots recalled the asymmetric power event. No pilot report was filed into the AML for this flight.

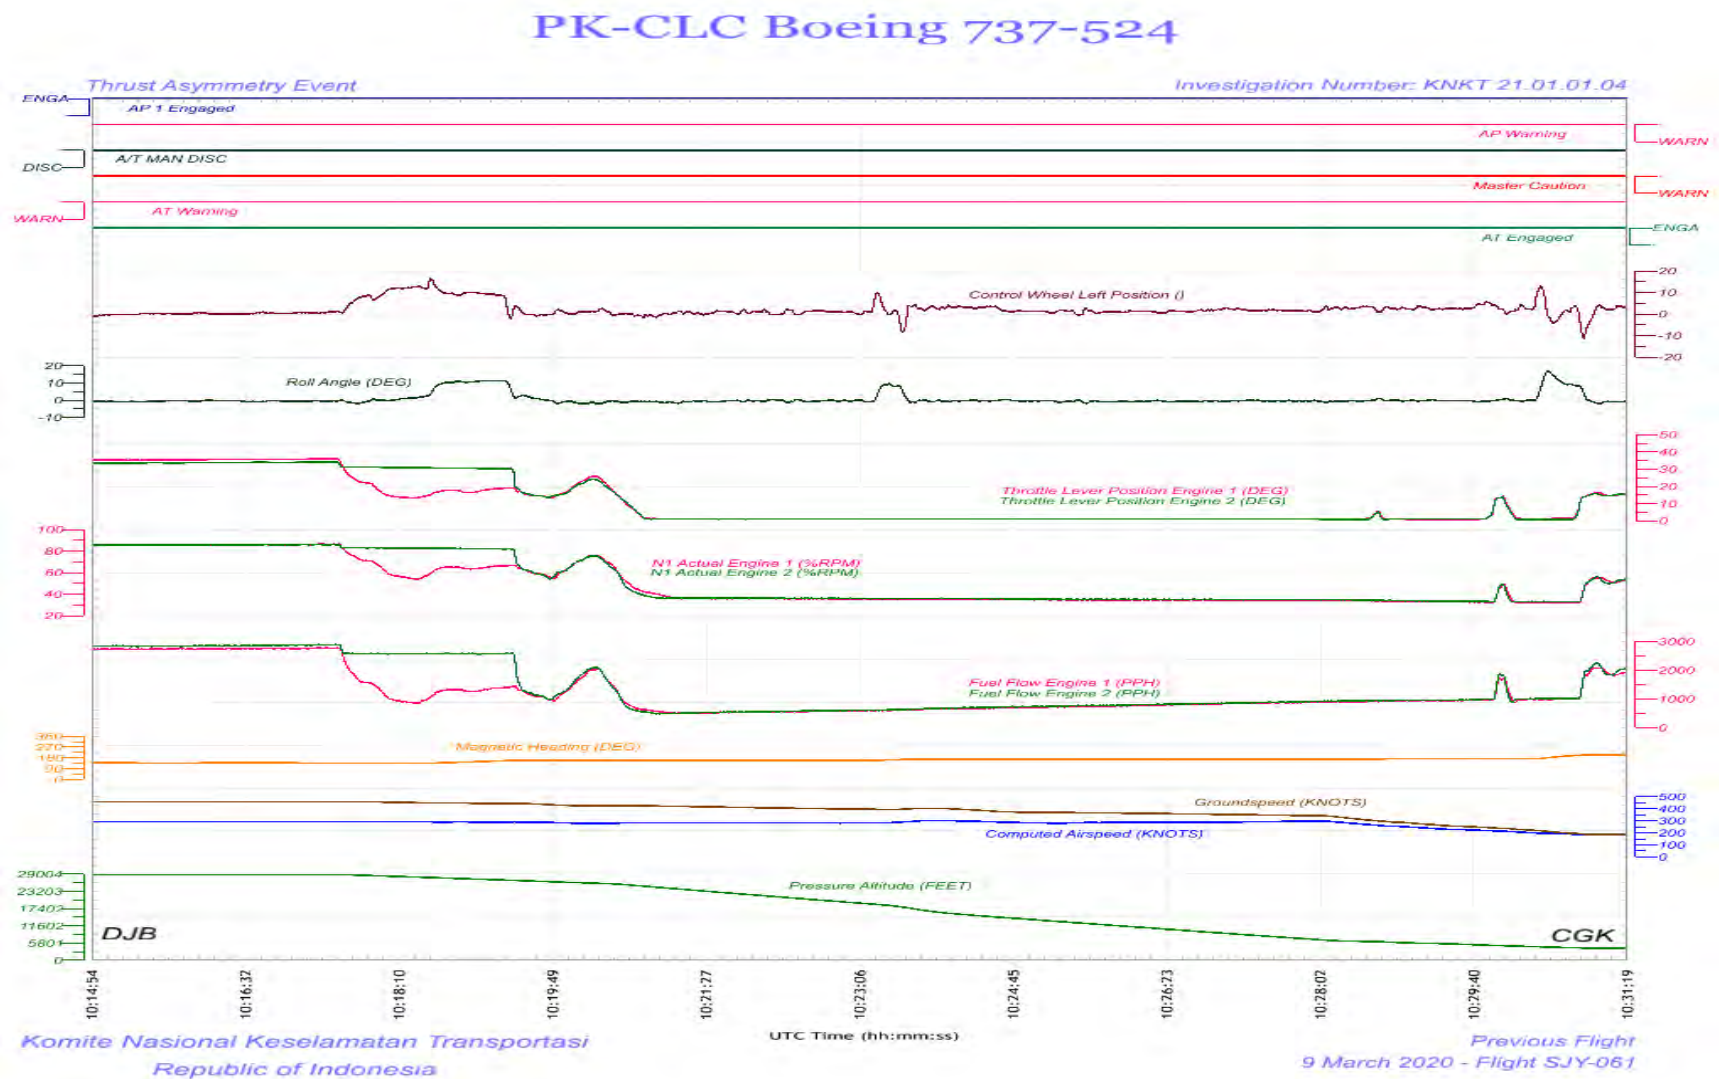
Figure 32: The QAR data of a flight on 9 March 2020

The QAR data of a flight on 9 March 2020 showed that:

The investigation team has interviewed both pilots of this flight. None of the pilots recalled the asymmetric power event. No pilot report was filed into the AML for this flight.

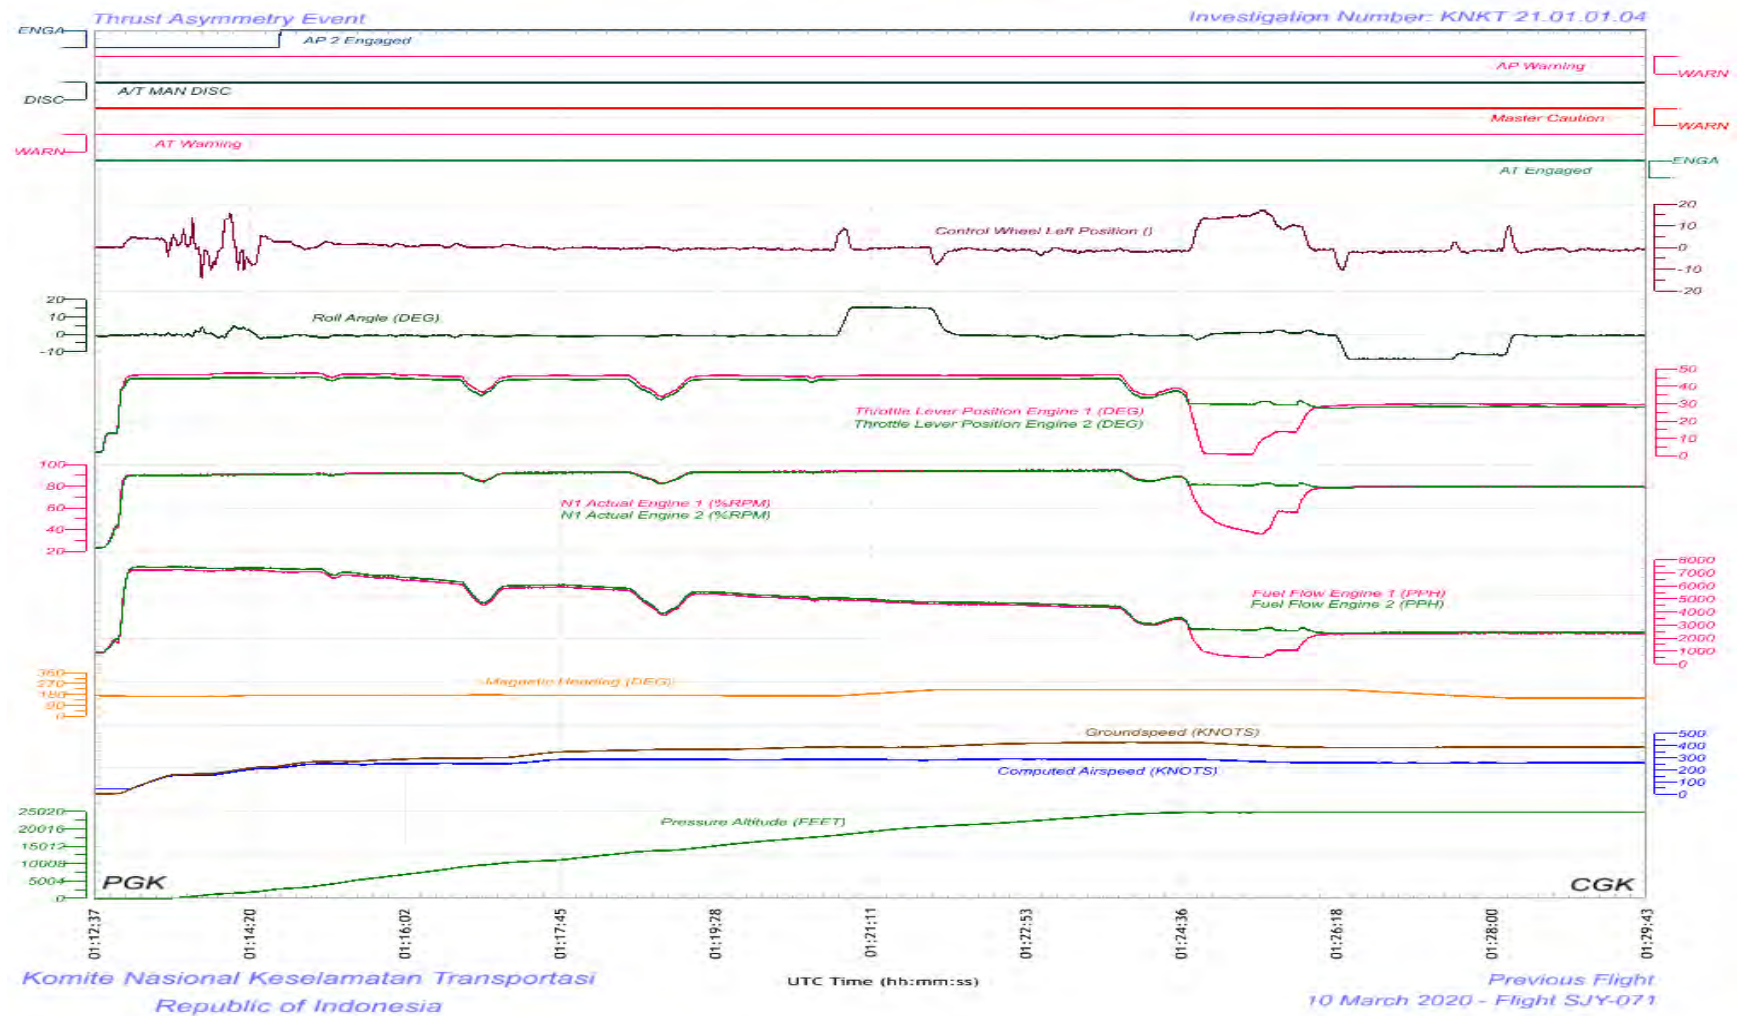
**Figure 33: The QAR data of a flight on 10 March 2020**

The QAR data of a flight on 10 March 2020 showed that:

The A/P and A/T remained engaged during this event. The flight continued without any further abnormality.

The investigation team has interviewed both pilots of this flight. None of the pilots recalled the asymmetric power event. No pilot report was filed into AML for this flight.

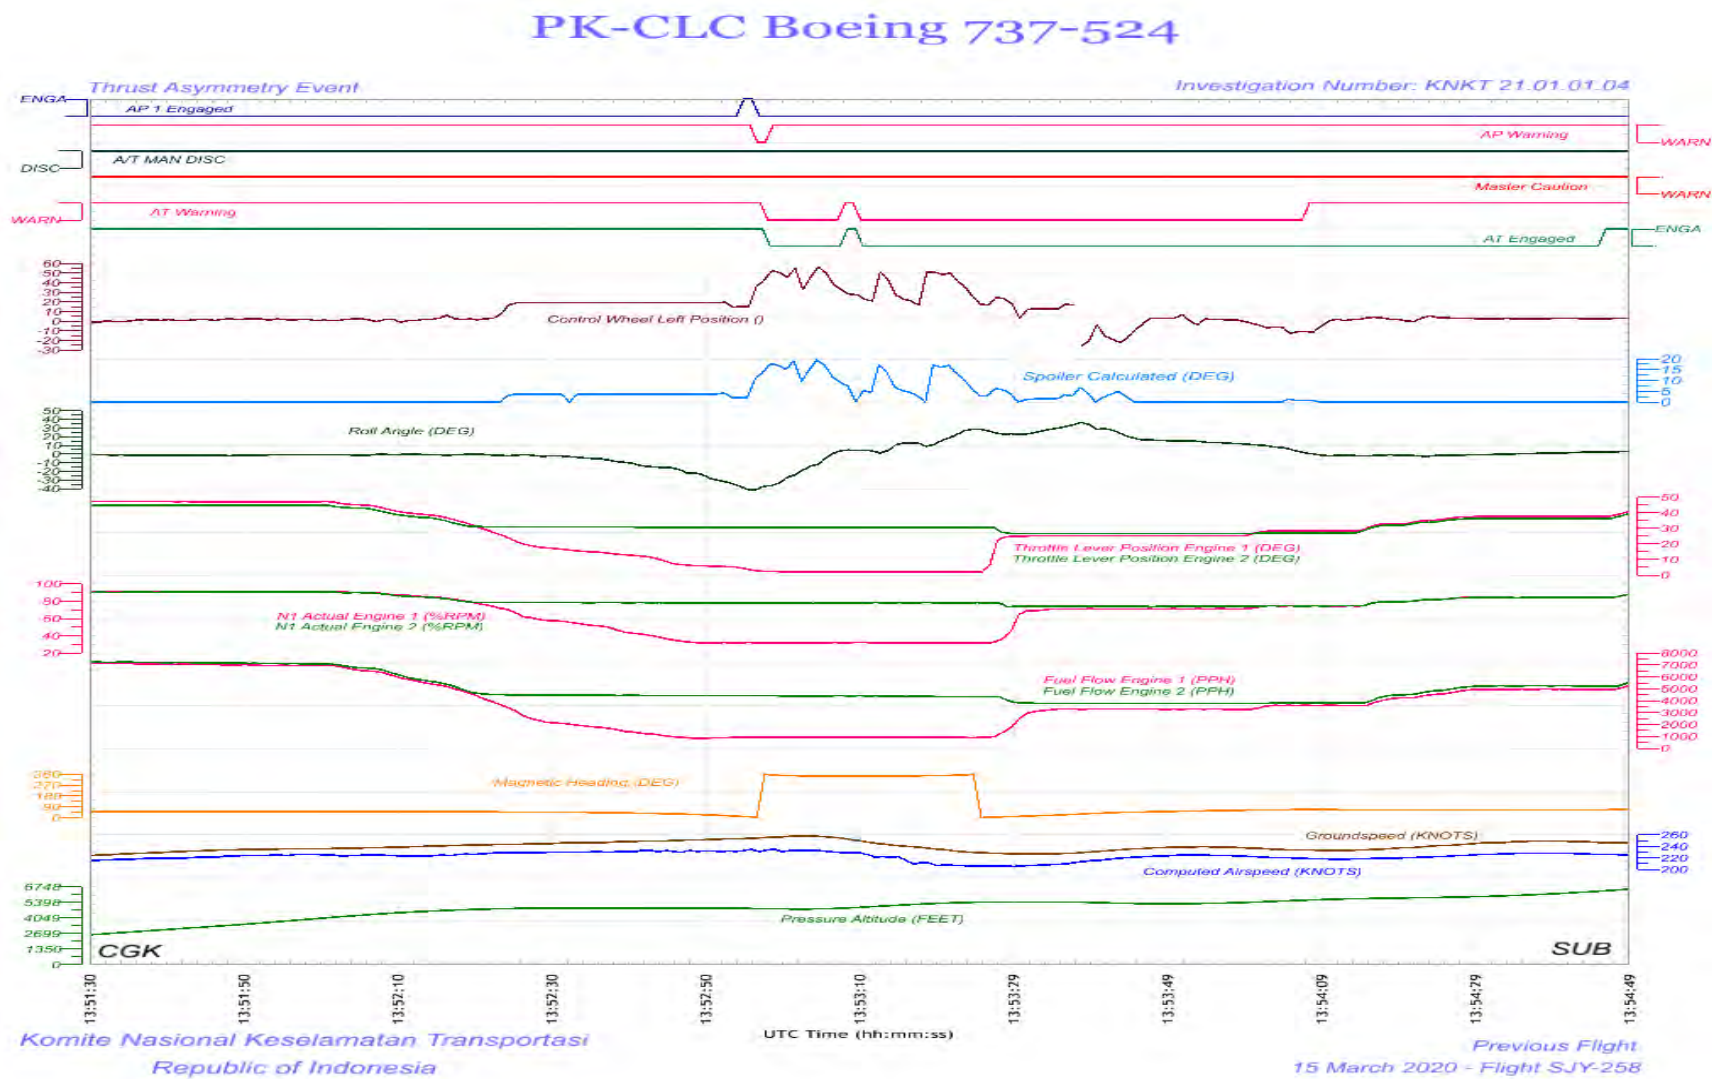
Figure 34: The QAR data of a flight on 15 March 2020 with additional parameter of spoiler deployment calculation

The QAR data of a flight on 15 March 2020 showed that:

The SIC recalled that during the flight, he acted as PF and while maintaining altitude of 5,000 feet, the ATC provided clearance to turn to the right. The SIC turned the heading selector on the MCP and noticed that the aircraft was unable to turn to the right. The SIC reported the condition to the PIC. The SIC then disengaged the A/P and turned the aircraft manually. After few moments the PIC realized that asymmetric thrust occurred, and the left thrust lever was at the idle position. Thereafter, both thrust levers restored to about 25° position, the aircraft returned to normal condition and no further anomalies occurred until landing. The SIC did not recall any additional details of the flight. Investigators were unable to determine how the PIC diagnosed the asymmetric thrust condition.

No pilot report of aircraft system malfunction was filed into the AML nor safety occurrence report to the operator safety reporting system.

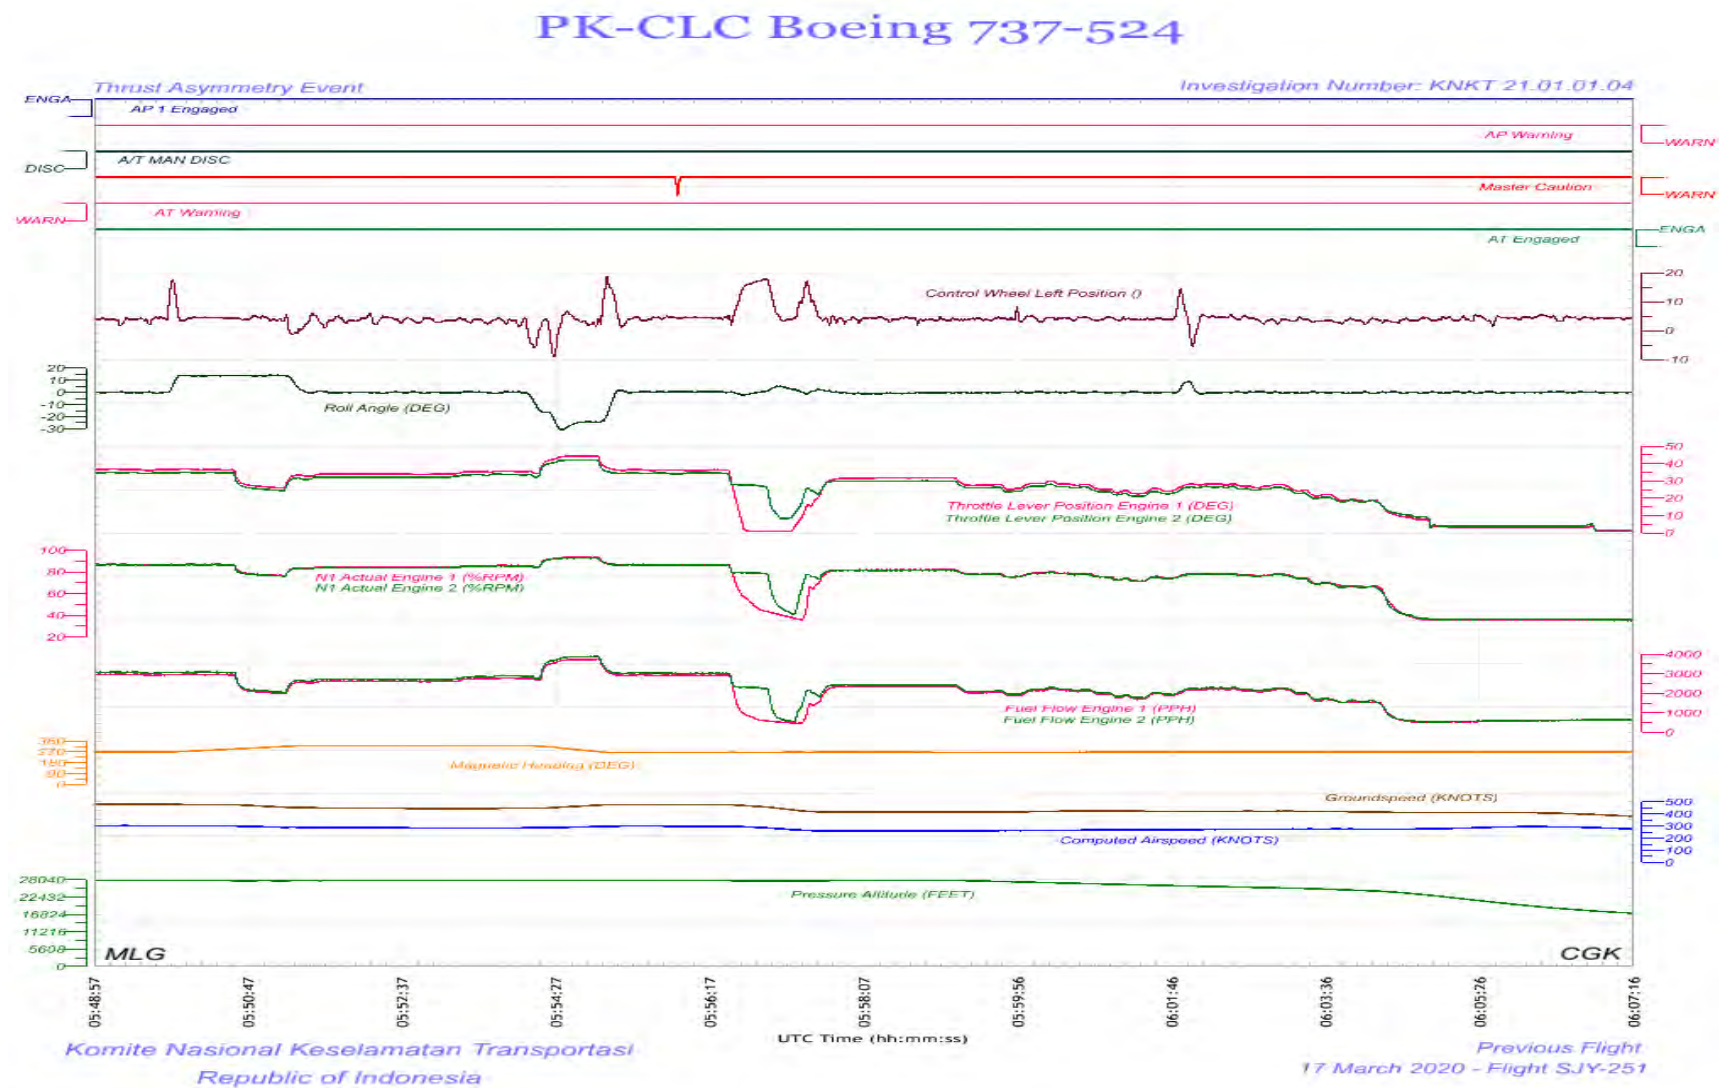
Figure 35: The QAR data of a flight on 17 March 2020

The QAR data of a flight on 17 March 2020 showed that:

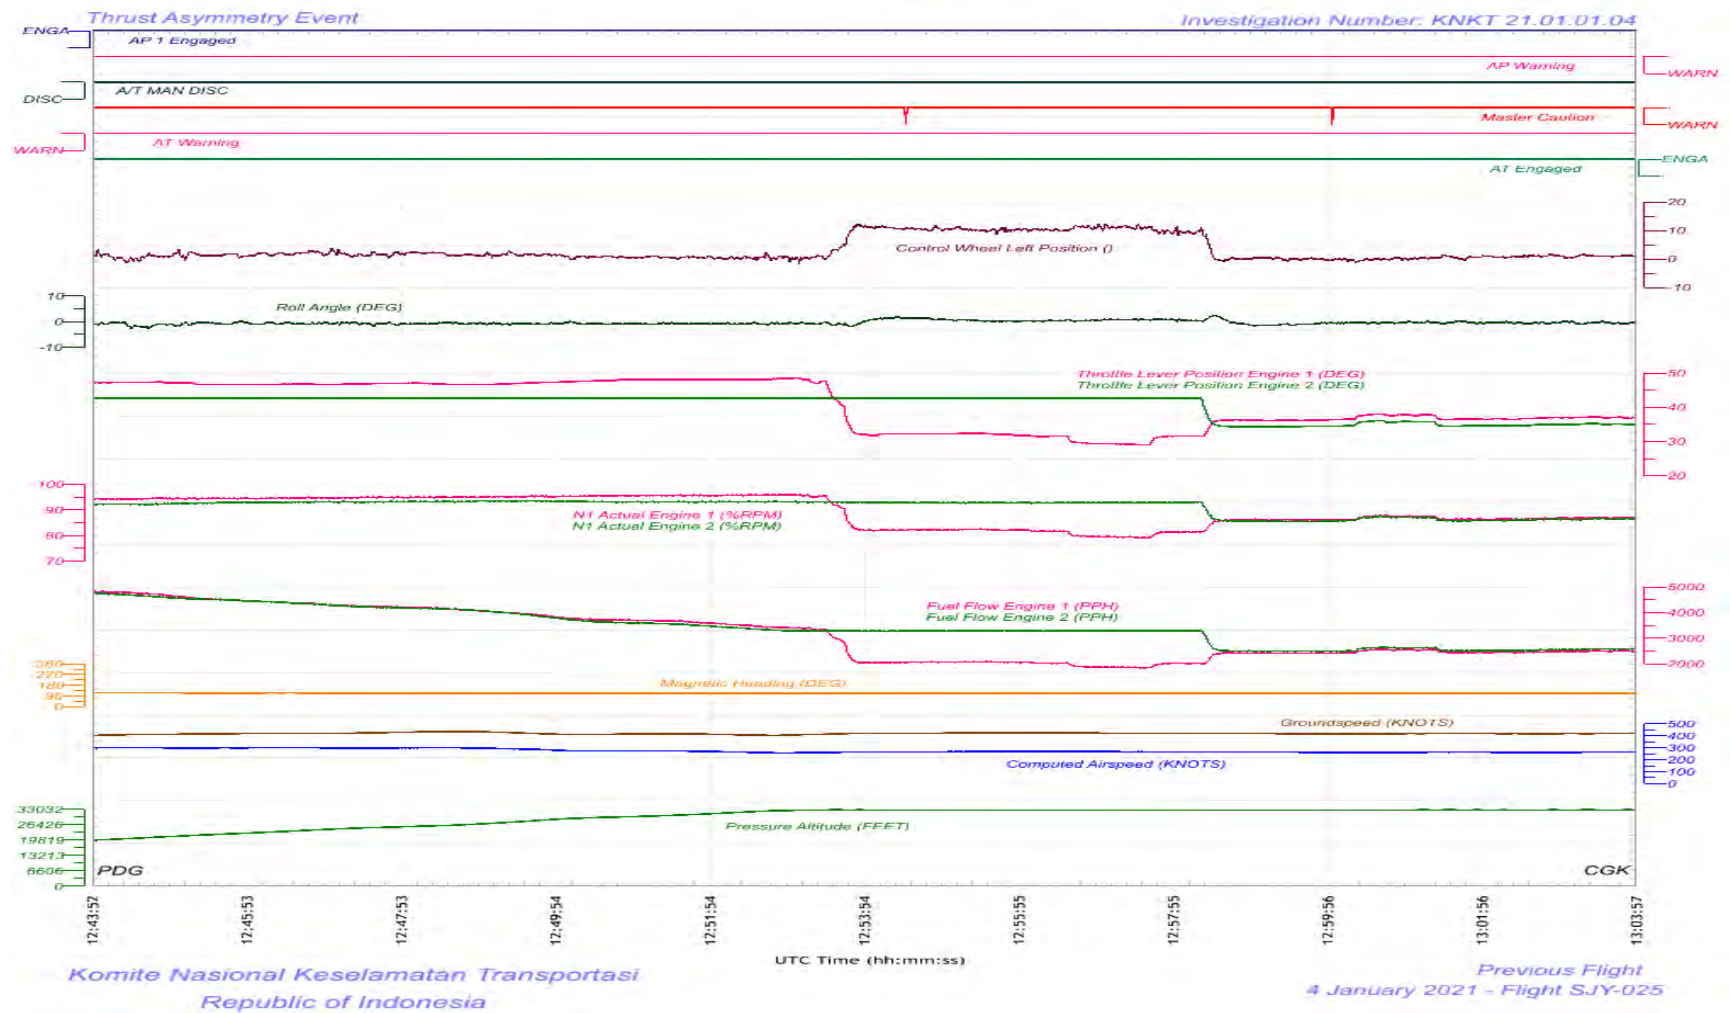
Figure 36: The QAR data of a flight on 4 January 2021

The QAR data of a flight on 4 January 2021 showed that:

The investigation has interviewed both pilots of this flight. None of the pilot recalled or identified asymmetric thrust levers during the flight. No pilot report was filed into the AML after this flight.

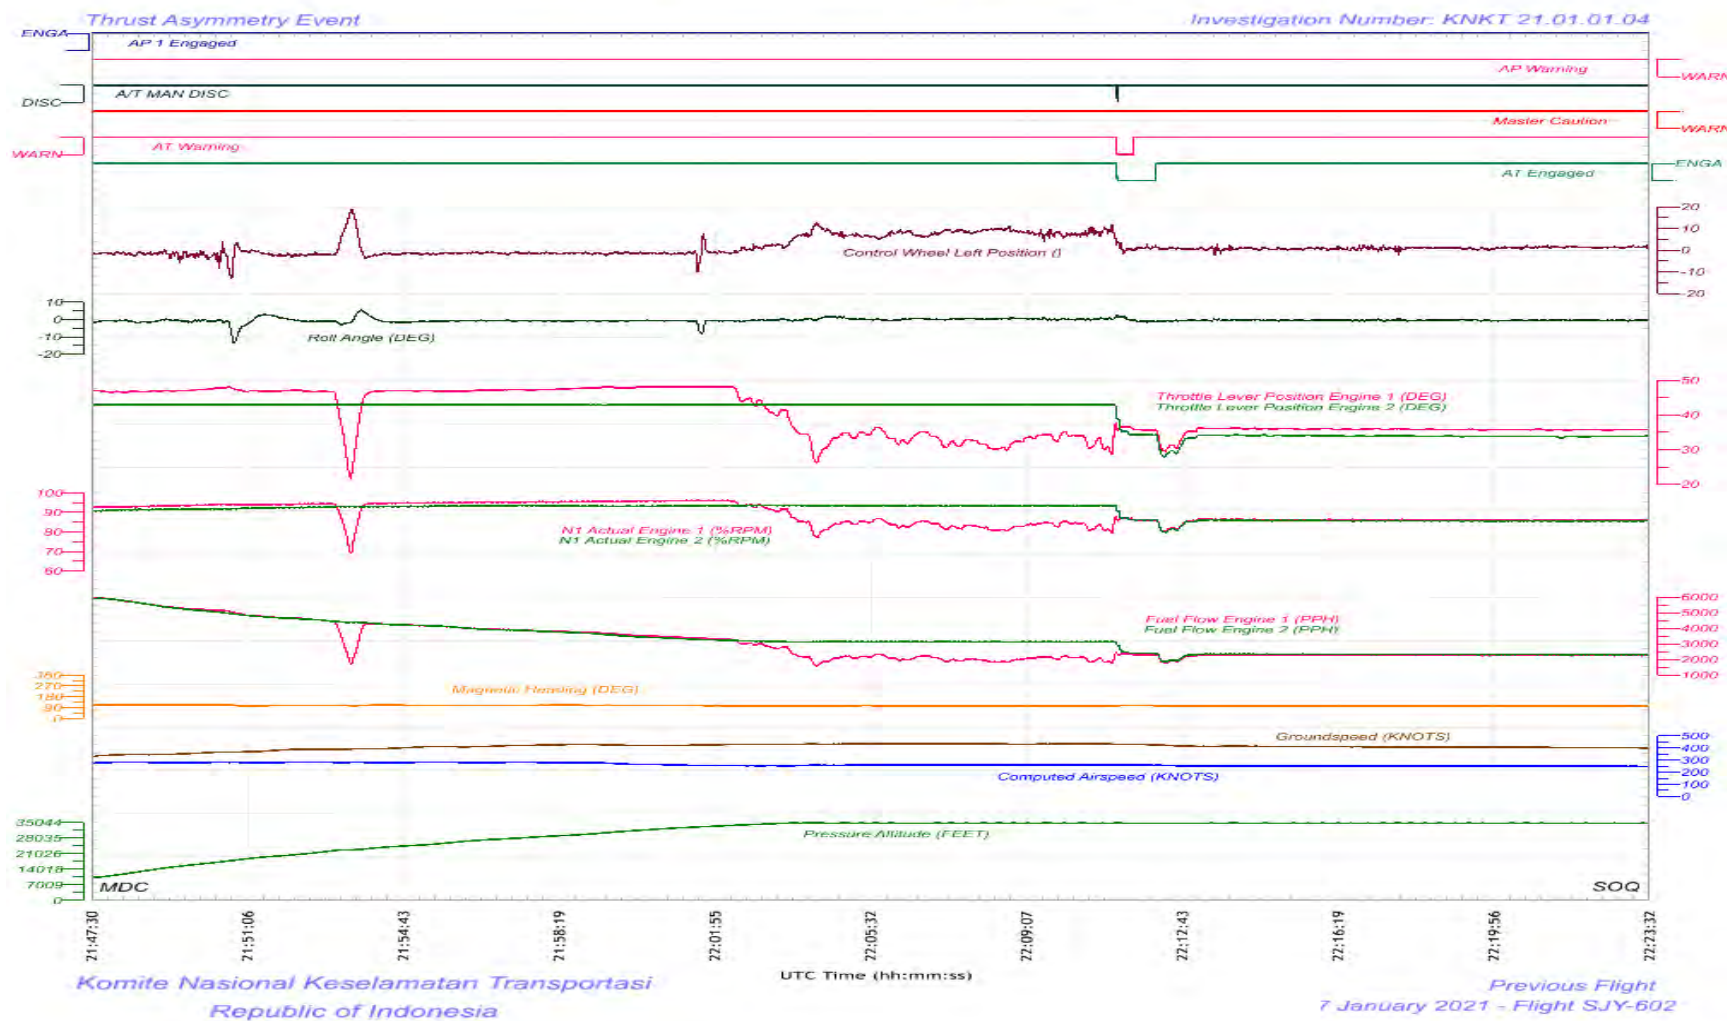
Figure 37: The QAR data of a flight on 7 January 2021

The QAR data of a flight on 7 January 2021 showed that:
